Letter Report

Sauget Area - Site Q, Cahokia, St. Clair County, Illinois

Technical Direction Document No. S05-0511-006

#### LETTER REPORT

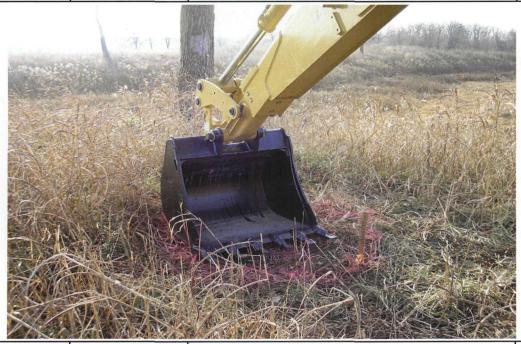
| TETRA TECH<br>PROJECT NO. | DESCRIPTION | Location of buried drums | 4 |

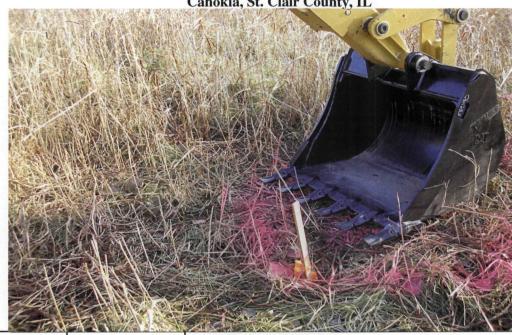
| | The state of the s | | |
|---|--|--|---|
| TETRA TECH<br>PROJECT NO. | DESCRIPTION | Staked location of drums determined by magnetometer survey | 5 |

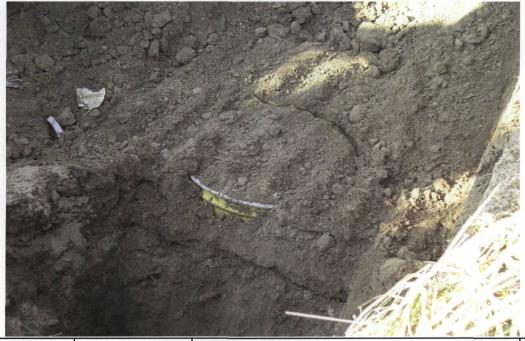
| TETRA TECH<br>PROJECT NO. | DESCRIPTION | Top of buried drum in upright position | 8 |

detected during the magnetometer survey were generated by scrap metal. START continued the excavation from Point 2 as the initial excavation area was enlarged. The drums were encountered at this location, and START confirmed the subsurface location of the drums by exposing the drum tops through manual excavation. START then continued excavation activities and removed both drums. Drum 1 was removed without incident, but the seal of Drum 2 was damaged during removal activities.

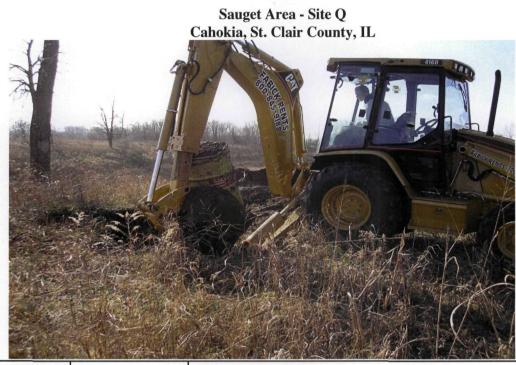
| Manager State of the State of t | | | |
|--|---|---|---|
| TETRA TECH<br>PROJECT NO. | DESCRIPTION | Drum 1 being brought to surface | 9 |

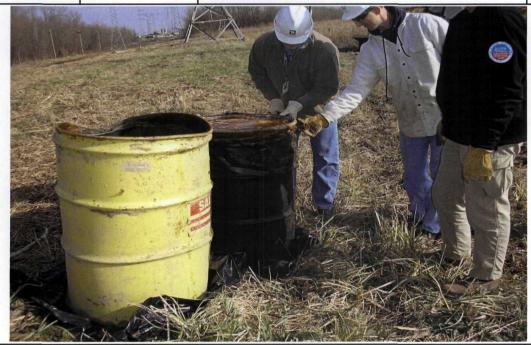
| TETRA TECH<br>PROJECT NO. | DESCRIPTION | Technicians removing lid of Drum 1 | 10 |

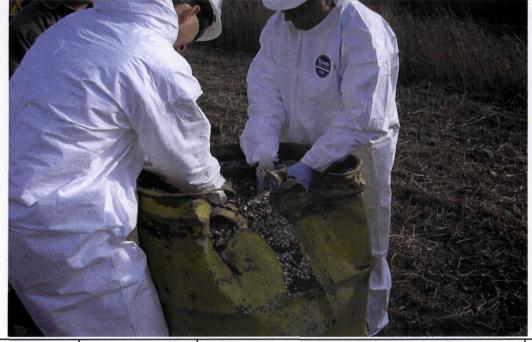
| TETRA TECH<br>PROJECT NO. | DESCRIPTION | Vermiculite packing material removed along with sample containers from Drum 2 | 12 |

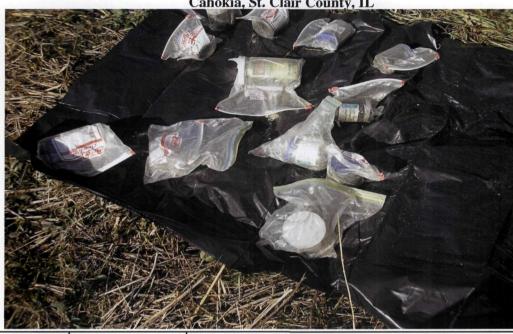
| TETRA TECH<br>PROJECT NO. | DESCRIPTION | Sample containers with residue on exterior of containers placed into zip-lock bags for handling purposes | 13 |

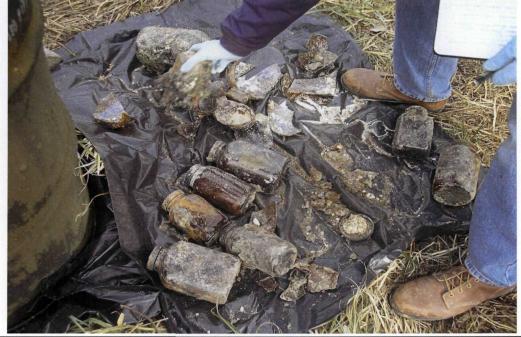
| TETRA TECH<br>PROJECT NO. | DESCRIPTION | Glass jars of chemical containers discovered during Site Q removal effort | 22 |

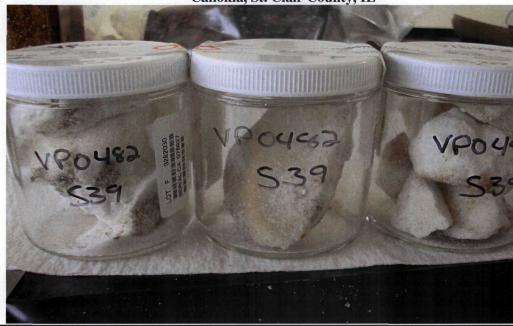
| | The second secon | TALL DESCRIPTION OF THE PROPERTY OF THE PROPER | |
|---|--|--|---|
| TETRA TECH<br>PROJECT NO. | DESCRIPTION | White crystalline substance placed into new sample containers | 23 |

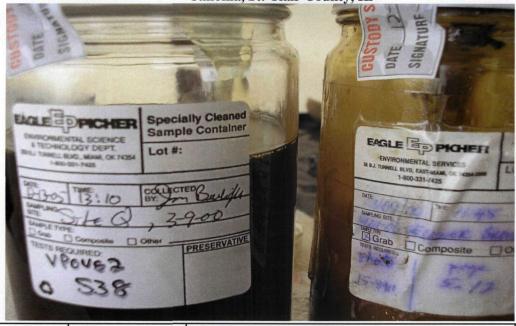
| TETRA TECH<br>PROJECT NO. | DESCRIPTION | Due to leaking seal on original jar, this liquid sample required re-containerization prior to sample shipment | 29 |

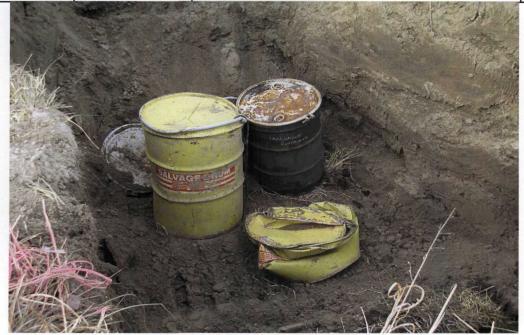
| TETRA TECH<br>PROJECT NO. | DESCRIPTION | Drum remnants placed back into excavation | 30 |

Jon Beihoffer, U.S. EPA NEIC Senior Chemist, sampled the drum contents. Upon completion of sampling activities, Drum 1 was re-packaged as it was found and repositioned within the excavation. Drum 2 was re-packaged, but the damaged drum over-pack was crushed prior to placement within the excavation. The excavation was then backfilled, and the area was restored to its original condition.

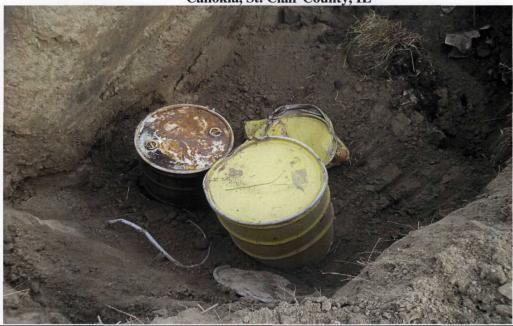
| DESCRIPTION | Drums returned to excavation | |

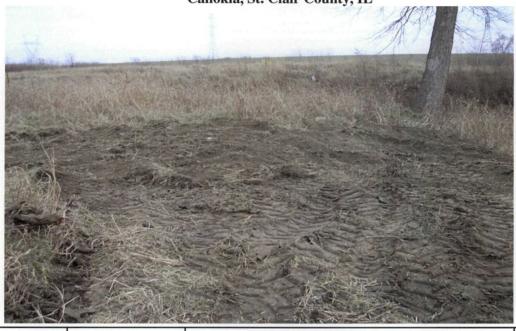
| | | | _ |
|---|---|--|---|
| TETRA TECH<br>PROJECT NO. | DESCRIPTION | Drum storage excavation backfilled and compacted | 33 |

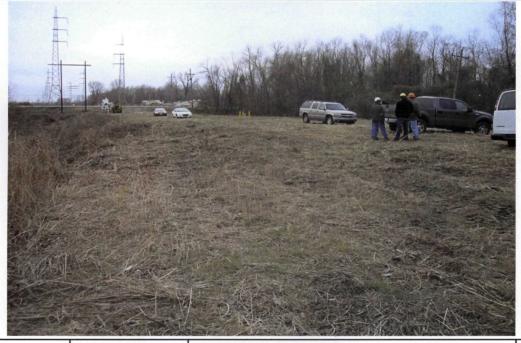
| TETRA TECH PROJECT NO. | DESCRIPTION | Site returned to original condition | 34 |
